DeerRun - Clubhouse Chimney Completion

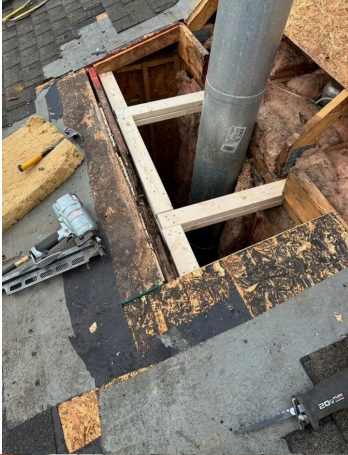
After demo of the existing wood rot chimney, we went ahead and replaced the support block framing just inside the roof. This way the new chimneys entire structure is all new and secured as best as possible.

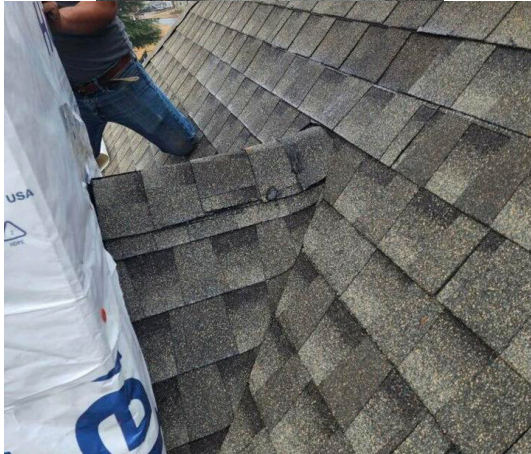
A new "cricket" rain diversion was Framed into the existing roof structure. We were able to source the exact shingles to match the existing. The new cricket runs the width of the chimney, so even in a heavy rain all storm water will divert away From the chimney structure and avoid any moisture damages From occurring. We did Flash and seal around the chimney structure as well prior to Framing the new chimney.

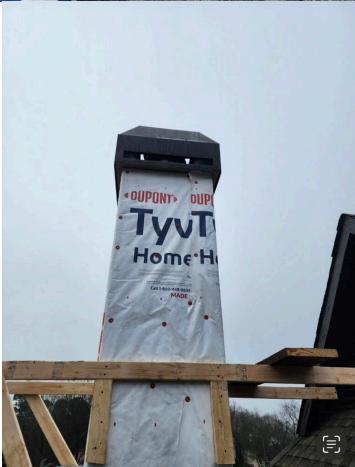
Installed the existing chimney cap, verified chimney was level and plum. Installed temporary support and bracing to ensure the chimney stayed level through the masonry process.

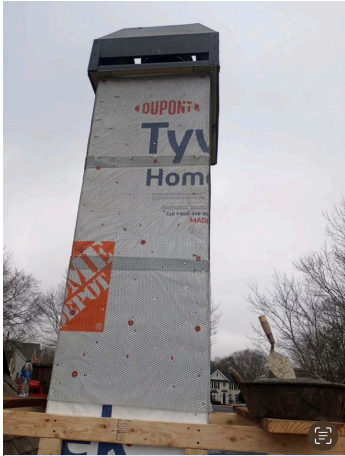
Installed wire mesh to prep for mortar to be applied and prep for new stone masonry.

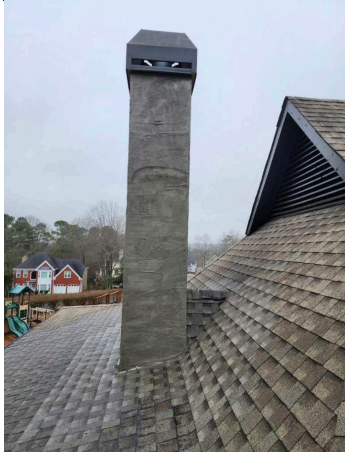
Applied mortar to the new chimney structure, we allowed 48 hours or cure time due to the lower temperatures outside prior to applying the new stone finish.

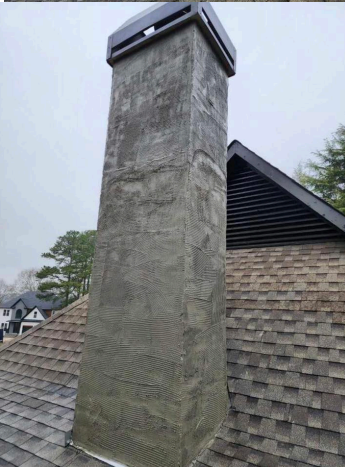
Mortar applied - view from left side of clubhouse.

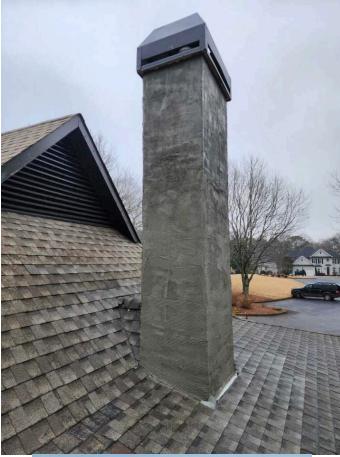
Mortar applied - view From rear of clubhouse.

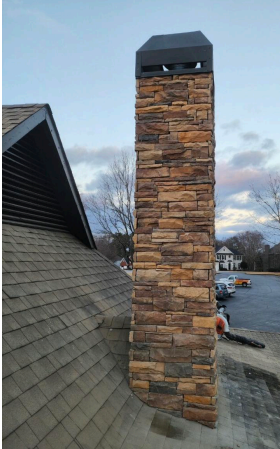
Stone Mason completion of new chimney, photo from standing on the rear of the clubhouse.

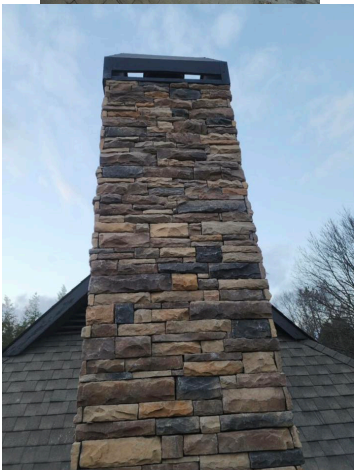
Stone Mason completion of chimney, view From standing on left side of clubhouse.

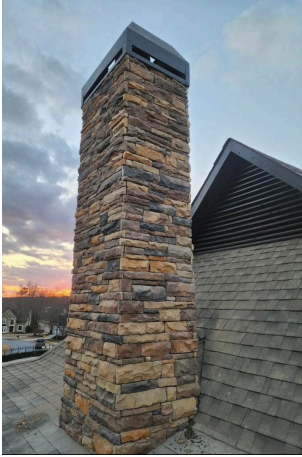
Stone Mason completion of the chimney, photo taken from standing at the front of the clubhouse.
